RE: Site Inspection, Geokinetics, Seep Ridge Mine, M/047/002, Uintah County, Utah

Date of Inspection: May 23, 2003
Time of Inspection: 5:30 to 6:20 p.m.
Conditions: Mostly clear, 80's
Participants: Paul Baker (DOGM)

M/047/002, Seep Ridge Mine, Geokinetics

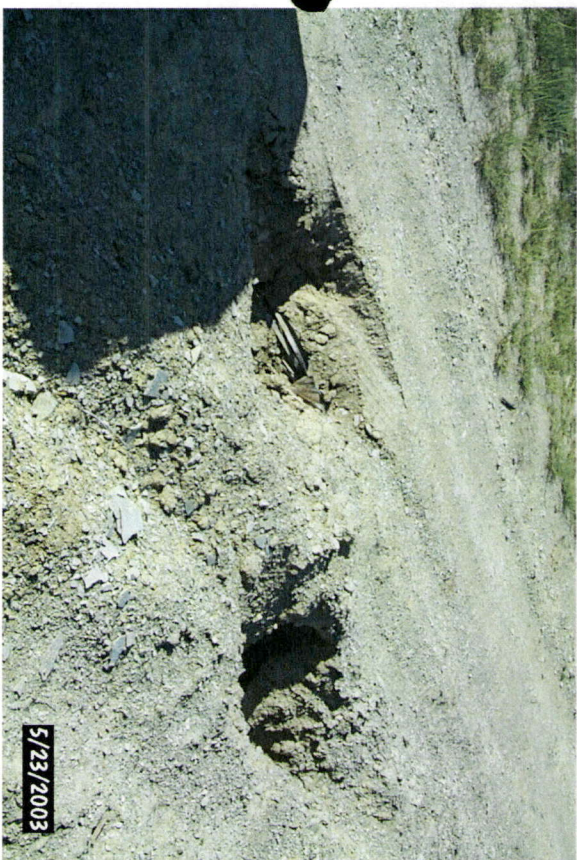
I followed the main road into the site that leads back toward the gas pipeline on the east side of the mine area. Last fall, the operator ripped part of this road, but it has become more driveable as people have continued to drive on it. There is one culvert in this road that was ripped open last fall although I don't believe it would have been apparent at the time. Since then, though, water has washed dirt into the rips in the culvert which has exposed the ripped up culvert (Photo 1). Although the operator had intended that this road be closed, the holes and the exposed metal from the culvert are hazards.

Photo 1. Places where water has piped into the ripped culvert.

The operator should remove the culvert. It may not have been visible when the site was being reclaimed, but it creates problems in its current condition. Although it would be much easier to use something like a backhoe to dig it out, I think it could be done by hand.

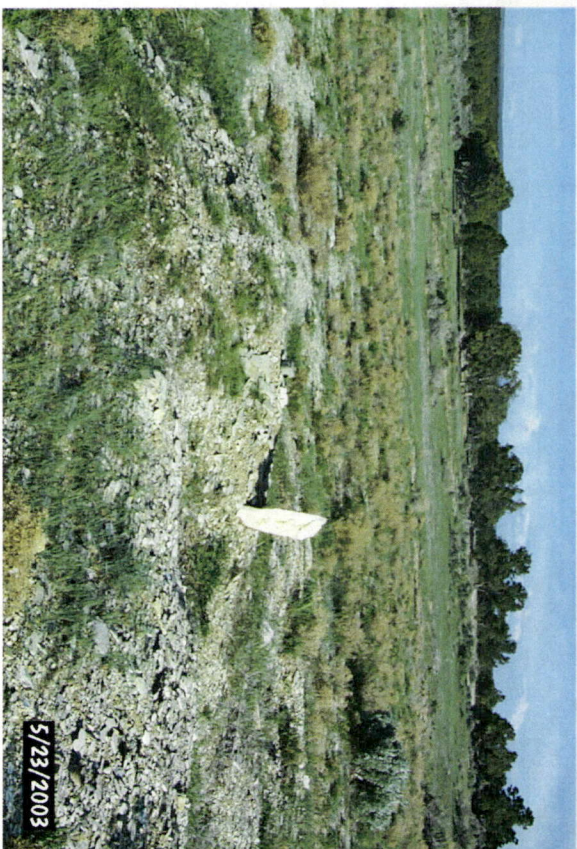
I next went to the trailer camp where there used to be a well. There are no records indicating this well was properly reclaimed, and one former employee indicated it may have just been covered up. I wanted to see if I could find any sign of the well near the center of the camp where maps indicate it was. I found a piece of exposed pipe, and, following the direction in which it lay, I found a

place where dirt had been heaped and a rock slab was placed almost like a grave marker (Photo 2). Near this rock, I found a cover from a pressure regulator for a water tank. I did not have any tools to dig and see if I could find anything here, but I think there is a good chance the well was/is at this location. I took a GPS point, and the UTM coordinates are 636,134 East, 4,388,246 North (see attached map). Other than this marker, this is a fairly non-descript point.

Photo 2. Possible well location in the trailer camp.

The next time someone is at the site, they should dig in the area of where I think the well might be to see if there is any sign of the well. If the well is found, it will need to be either upgraded to where it could be used for a postmining land use or properly abandoned.
